**Flood Control Project Maintenance
Levee Inspections**
LMA District Cover Sheet
Spring 2018 Levee Inspection Results

Reclamation District No. 0150 Merrit Island

Spring 2018 Levee Inspection Results

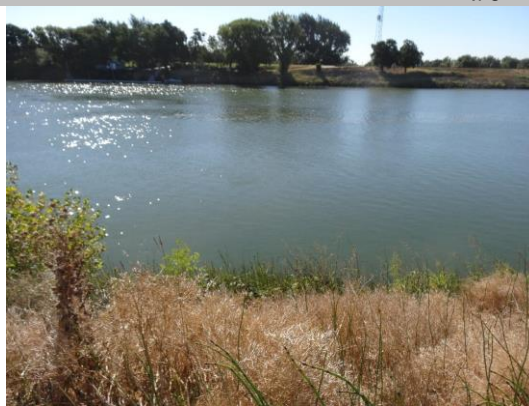
Photo 1 of 3 : UCIP_SP_2018_42700_34247.jpg

LM Start	0.23	Rating **	M	Issue No.	991
LM End	0.23	Issue Type +	En	Location *	
Category	Supplemental			GPS Latitude/Longitude	
				Start	End
Item	DWR UCIP Field Study			38.330888 °	38.330888 °
				-121.573769 °	-121.573769 °
DWR ID					
Comment Code					
Inspector Comment					
FS_ID:42700 DS_ID:22416 EP_NO: N/A Repair Type: Non-Urgent Crossing Status: Found UCIP Comments: Appears abandoned and if so should be done so properly.- Dense vegetation on waterside.- Seems abandoned pipe and pump. FIELD_STRUCT_DESC: *ABANDONED* 10-inch steel irrigation discharge pipe through the levee, invert elevation 2.8 feet below the crown. Pump on the landside (LS). Concrete box on the LS. (Thomas Estate). [Additional Reference(s): DWR Levee Log, 2005. USACE Sacramento O&M Manual 112, March 1957, (RM 34.23)]. FS Date: 8/27/2013

WS view: No pipe found on waterside slope. Dense vegetation on waterside.

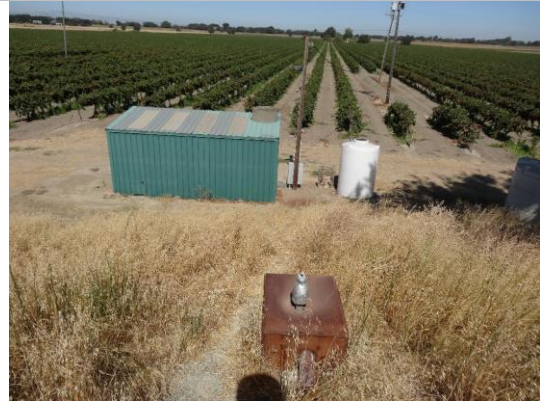
Photo 3 of 3 : UCIP_SP_2018_20303_34285.jpg

LS view: 10-inch pipe and air vent on levee slope. Concrete standpipe inside water filtration plant.

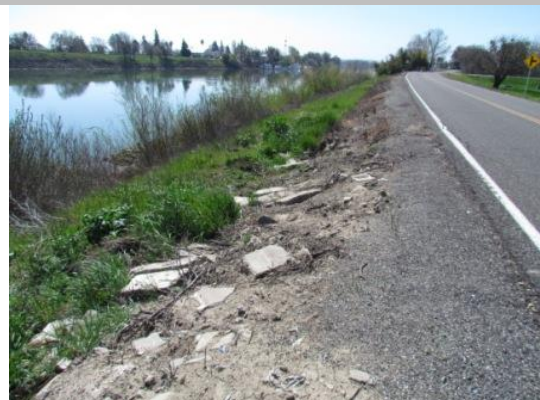
Photo 1 of 1 : SP_2018_RD0150_16_10_20180301_00006.jpg

Debris was found on the waterside slope of the levee looking downstream during spring 2013 inspection.

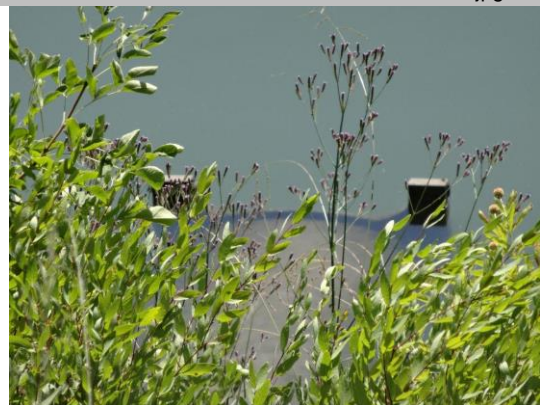
Photo 2 of 3 : UCIP_SP_2018_20346_34349.jpg

WS view: submerged flap gate in the stream.

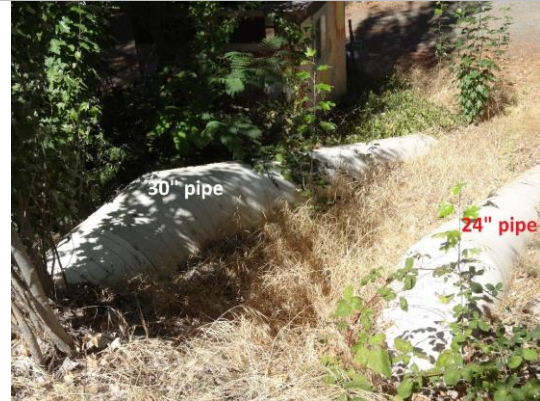
Photo 3 of 3 : UCIP_SP_2018_20346_34348.jpg

LS view: exposed 30" pipe (left) and 24" pipe (right) on levee slope.

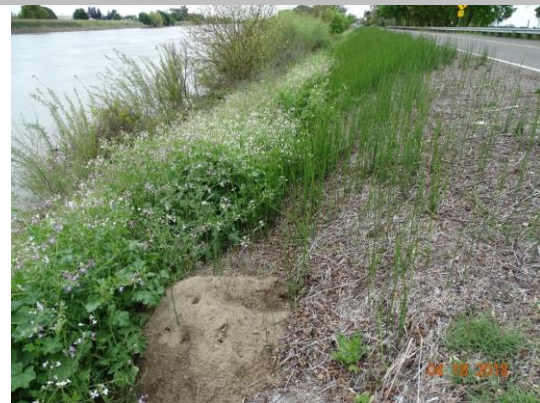
Photo 1 of 1 : SP_2018_RD0150_16_96_20180418_00131.jpg

Rodent control waterside looking southeast.

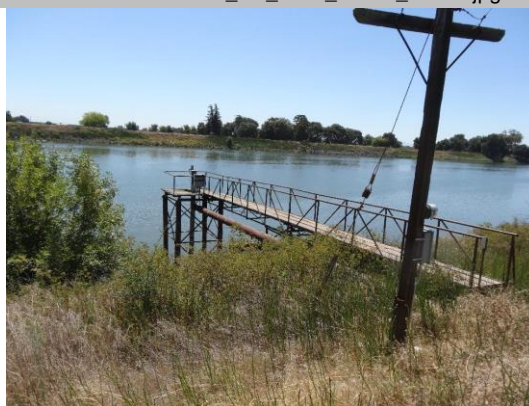
Photo 1 of 3 : UCIP_SP_2018_20348_34371.jpg

WS view: service pole, pipe & pump on piling structure in the stream.

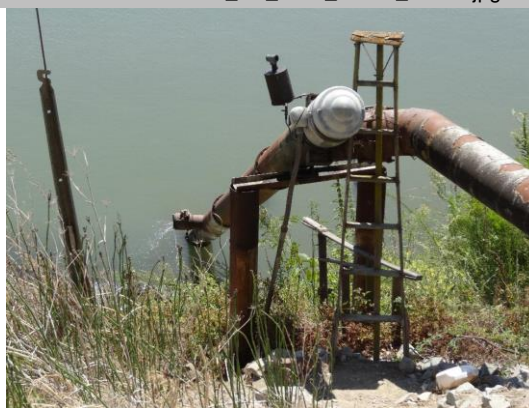
Photo 1 of 3 : UCIP_SP_2018_20731_34902.jpg

WS view: slant pump on steel frame support and exposed pipe on levee slope.

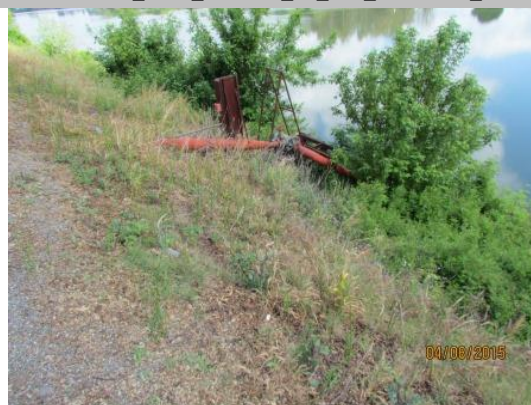
Photo 1 of 5 : SP_2018_RD0150_16_961_20180301_00061.jpg

Updated picture of the erosion on the waterside of the levee during spring 2015 inspection.

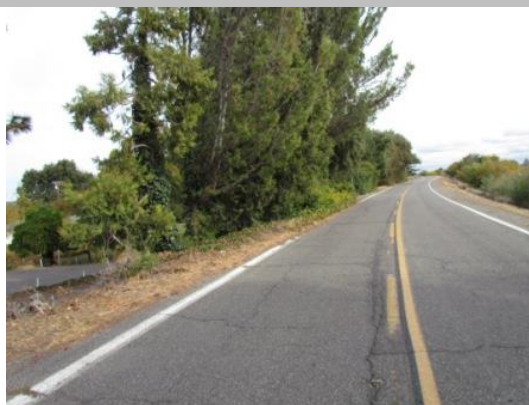
Photo 1 of 1 : SP_2018_RD0150_16_82_20180301_00055.jpg

Landscaping was blocking the visibility on the landside of the levee looking upstream.

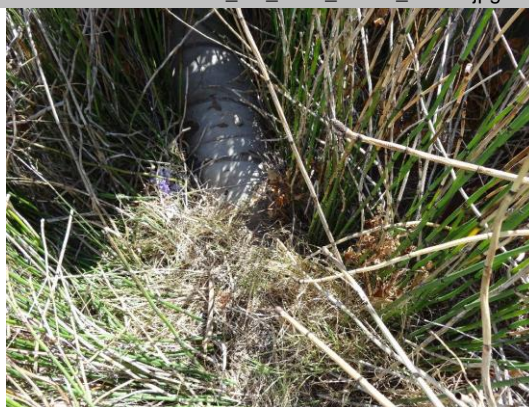
Photo 2 of 3 : UCIP_SP_2018_42702_33781.jpg

WS view: exposed 14-inch steel pipe on levee slope.

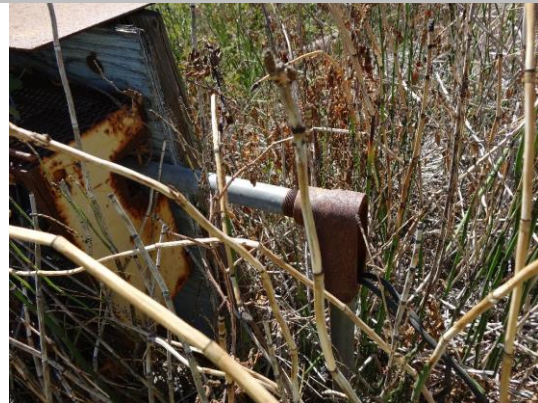
Photo 3 of 3 : UCIP_SP_2018_42702_33780.jpg

WS view: electric control box and electric conduit on levee slope.

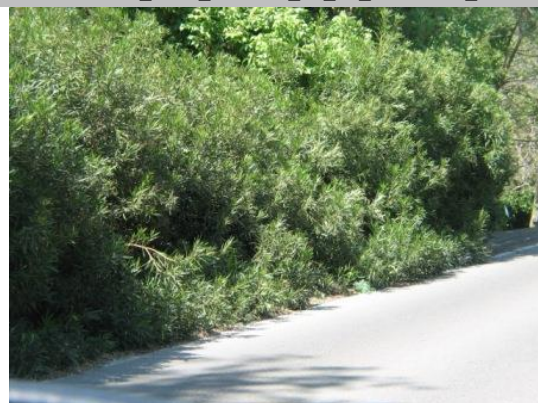
Photo 1 of 1 : SP_2018_RD0150_16_24_20180301_00011.jpg

Landscaping (Oleander) on landward slope from 4.33 to 4.35

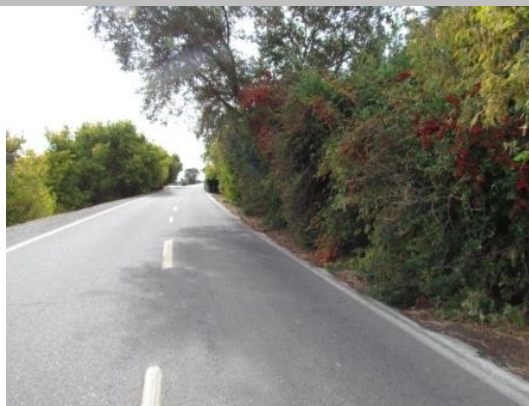
Photo 1 of 1 : SP_2018_RD0150_16_79_20180301_00053.jpg

Trees were obstructing the views on the landside slope of the levee looking downstream.

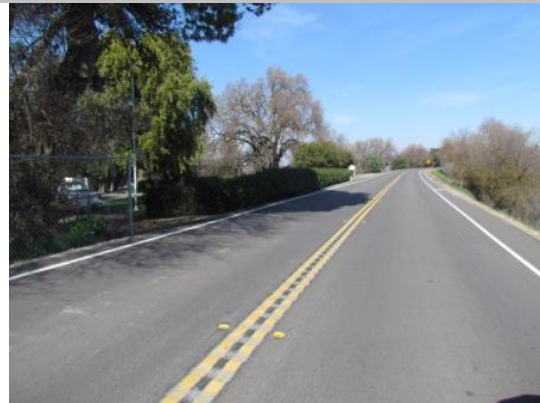
Photo 1 of 1 : SP_2018_RD0150_16_30_20180301_00014.jpg

Landscaping was found on the landside shoulder of the levee looking upstream.

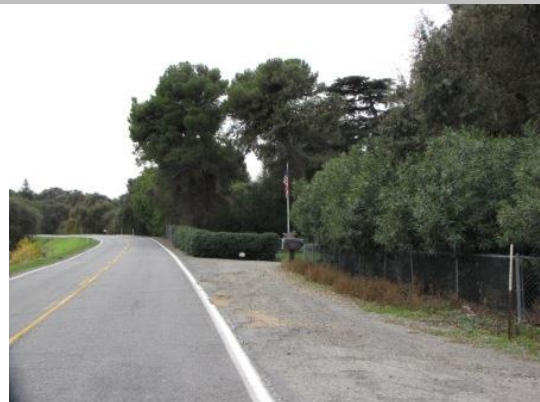
Photo 1 of 1 : SP_2018_RD0150_16_75_20180301_00051.jpg

View of landscaping along the landward shoulder and slope looking downstream.

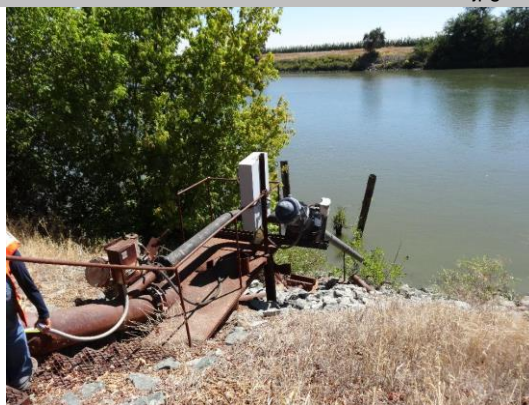
Photo 1 of 3 : UCIP_SP_2018_20740_34941.jpg

WS view: pipe, walkway, slant pump & pump platform on stream bank.

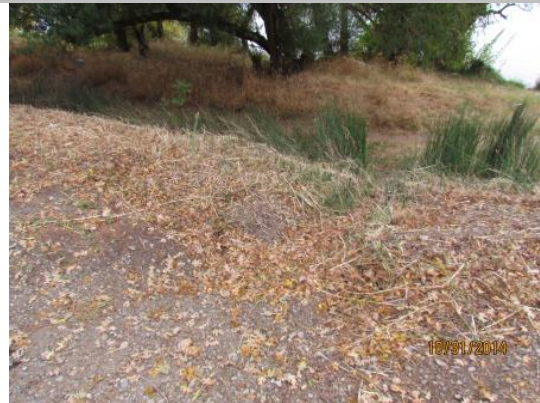
Photo 1 of 1 : SP_2018_RD0150_16_54_20180301_00036.jpg

View of a slope instability on the waterside of the levee looking towards the toe.

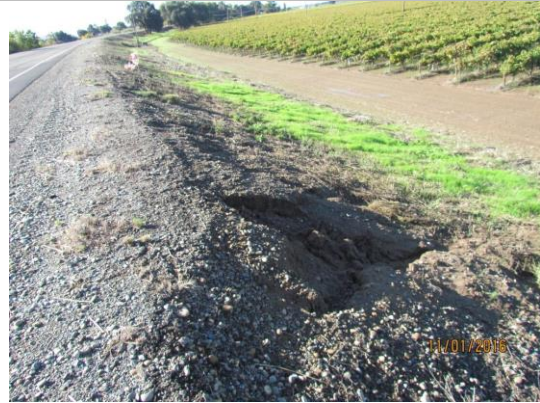
Photo 2 of 2 : SP_2018_RD0150_16_52_20180301_00032.jpg

View of an erosion due to runoff on the landside of the levee. Fall 2016

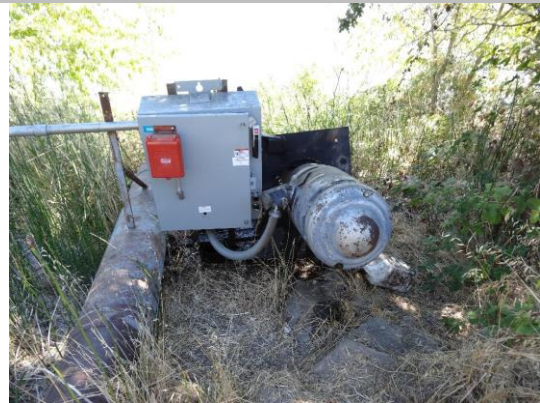
Photo 1 of 3 : UCIP_SP_2018_20748_34967.jpg

WS view: steel pipe and slant pump on levee slope.

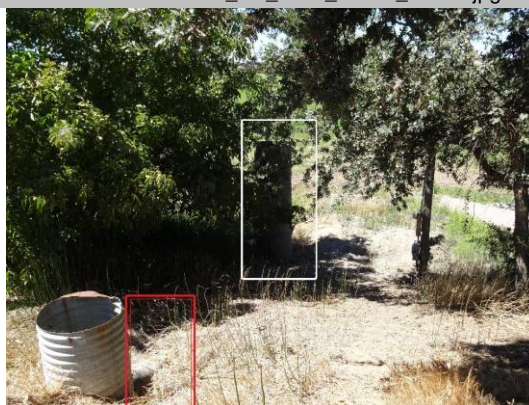
Photo 3 of 3 : UCIP_SP_2018_20748_34965.jpg

LS view: siphon breaker in CMP riser (left) on levee slope and concrete standpipe at levee toe (right).

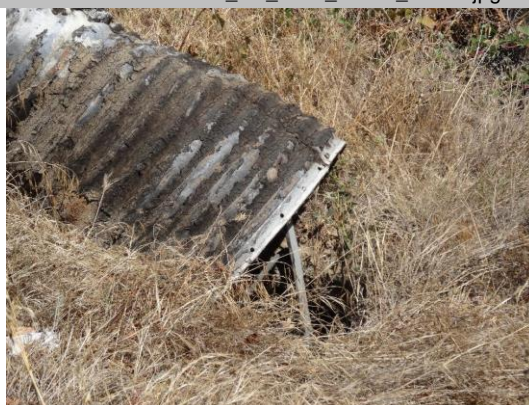
Photo 2 of 3 : UCIP_SP_2018_50669_34984.jpg

WS view: closer view of an abandoned and dismantled CMP riser on WS levee slope.

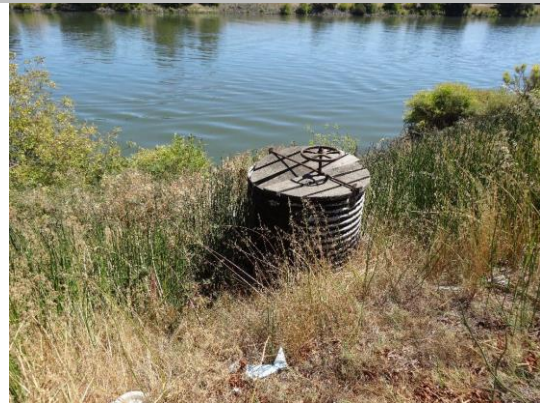
Photo 1 of 2 : UCIP_SP_2018_41720_34081.jpg

WS view: CMP riser with gate valve on levee slope. Dense vegetation on levee slope and stream bank.

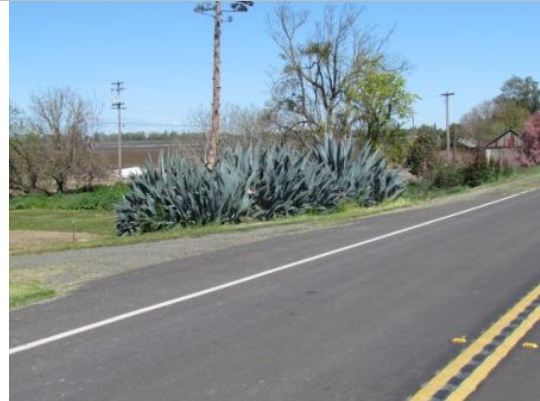
Photo 1 of 1 : SP_2018_RD0150_16_43_20180301_00019.jpg

Century plants were found on the landside of the levee looking upstream.

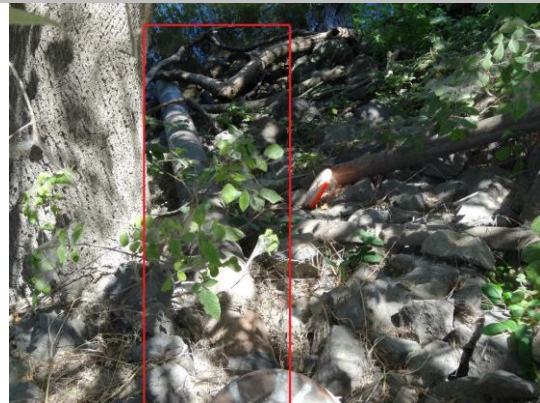
Photo 1 of 3 : UCIP_SP_2018_41646_34102.jpg

WS view: inlet steel pipe on stream bank.

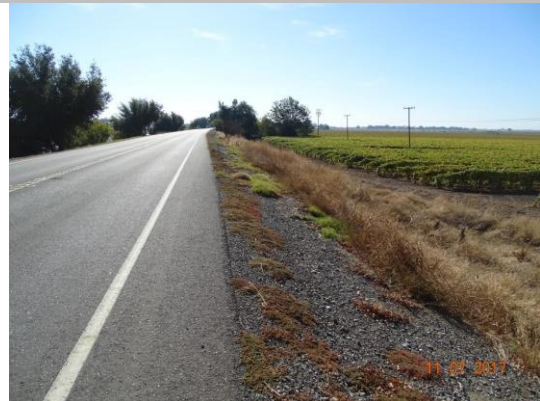
Photo 1 of 1 : SP_2018_RD0150_16_57_20180301_00039.jpg

View of vegetation on the landside of the levee. Fall 2017

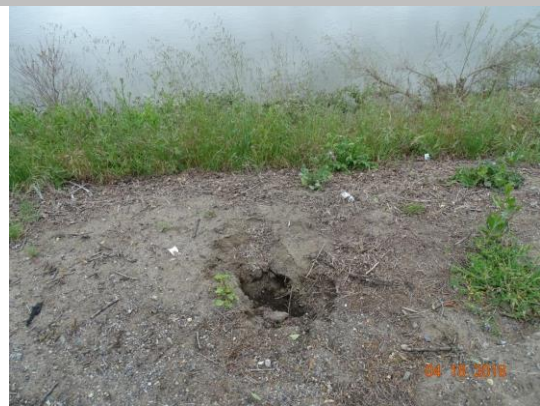
Photo 1 of 1 : SP_2018_RD0150_16_111_20180418_00133.jpg

Erosion bank caving waterside looking east.

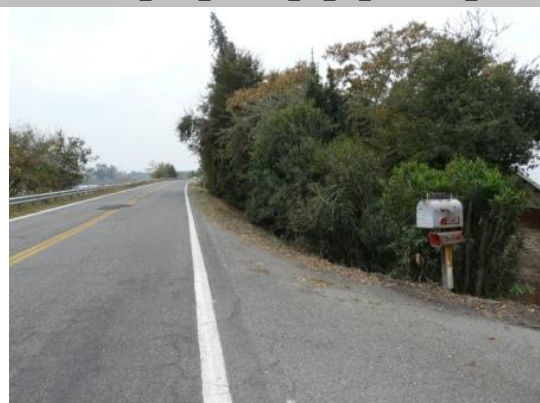
Photo 1 of 1 : SP_2018_RD0150_16_60_20180301_00043.jpg

Landscaping providing a screen for a residence on the landside of levee from LM 6.93 to LM 7.05

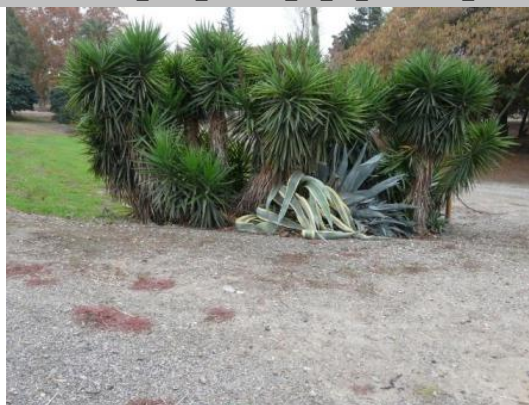
Photo 1 of 1 : SP_2018_RD0150_16_56_20180301_00038.jpg

Landscaping on landside of levee at LM 7.92

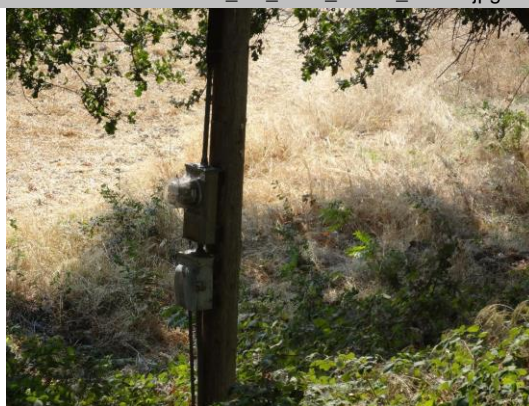
Photo 1 of 3 : UCIP_SP_2018_42693_31979.jpg

LS view: service pole on levee slope.

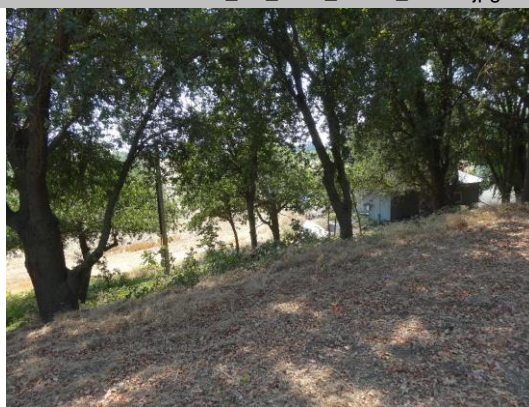
Photo 2 of 3 : UCIP_SP_2018_42693_31978.jpg

LS view: no pipe on levee slope.

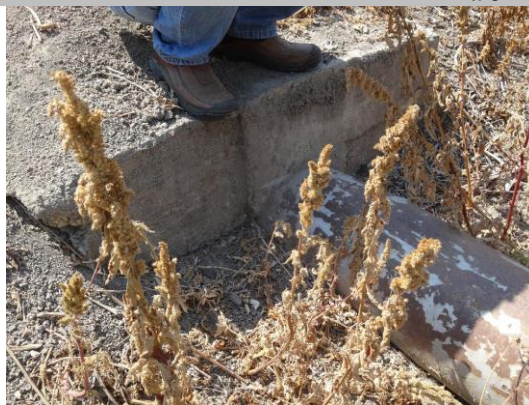
Photo 2 of 3 : UCIP_SP_2018_19112_32043.jpg

WS view: concrete headwall and exposed pipe on levee slope.

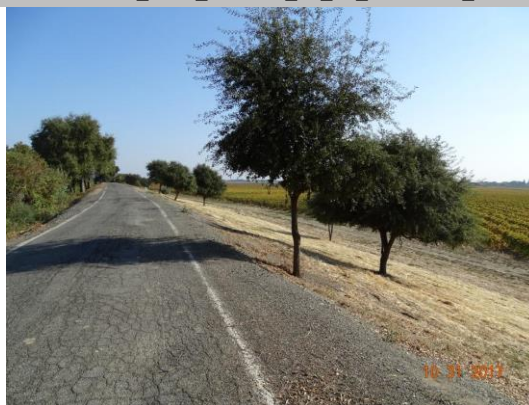
Photo 1 of 4 : SP_2018_RD0150_17_78_20180301_00073.jpg

Updated picture of the trees on the landside of the levee during fall 2017 inspection.

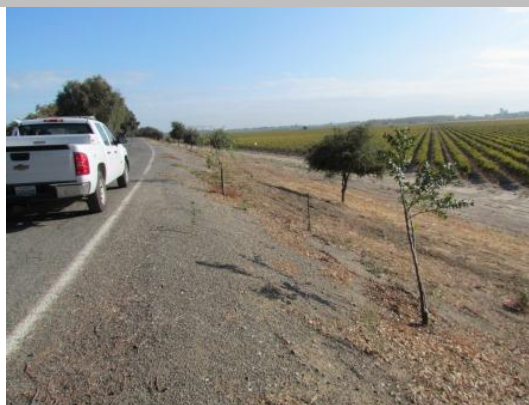
Photo 3 of 4 : SP_2018_RD0150_17_78_20180301_00075.jpg

Several newly planted trees were found on the landside slope of the levee looking upstream during the fall 2013 inspection.

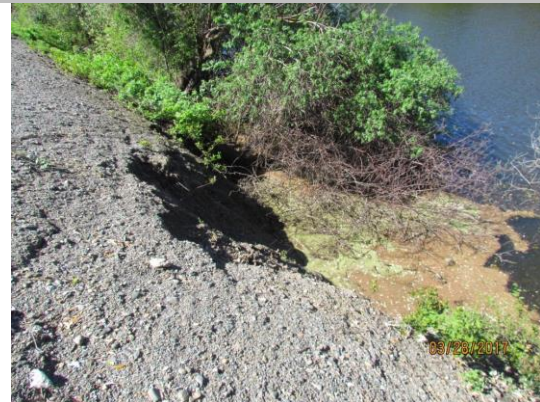
Photo 1 of 1 : SP_2018_RD0150_17_54_20180301_00050.jpg

LM Start	2.52	Rating **	A/W	Issue No.	54
LM End	2.52	Issue Type +	Ma	Location *	WS
Category	Earthen Levee			GPS Latitude/Longitude	
				Start	End
Item	Erosion / Bank Caving			38.356398 °	38.356398 °
				-121.561834 °	-121.561834 °
DWR ID	DWR_RD0150_03_s_2017_54				
Comment Code					
E2 : Schedule repair of erosion site prior to the next inspection.					
Inspector Comment

View of an erosion on the waterside slope of the levee looking downstream.

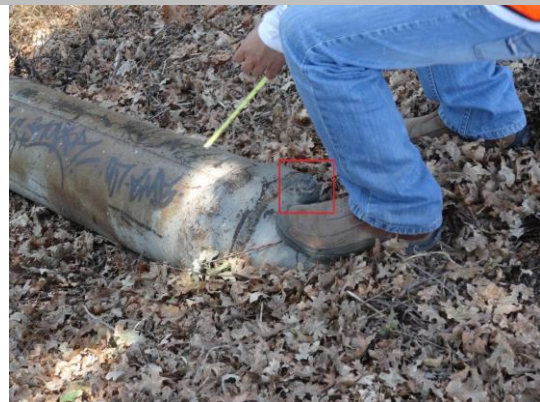
Photo 2 of 3 : UCIP_SP_2018_50202_35021.jpg

WS view: steel pipe with safety valve (marked) on levee slope.

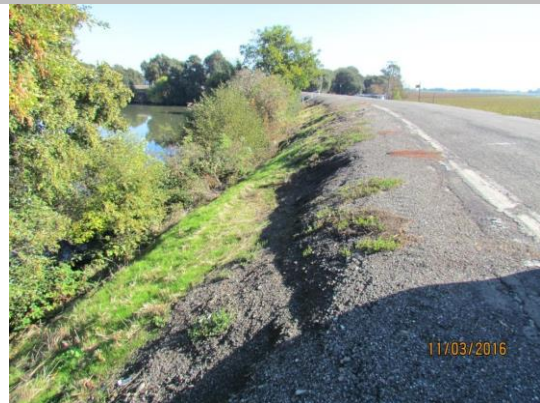
Photo 1 of 1 : SP_2018_RD0150_17_116_20180301_00127.jpg

View of slope instability on the waterside of the levee. Fall 2016

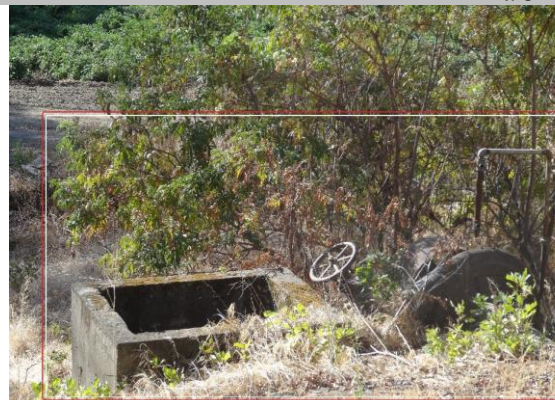
Photo 2 of 3 : UCIP_SP_2018_19283_32564.jpg

LS view: abandoned pump set and concrete box on levee slope.

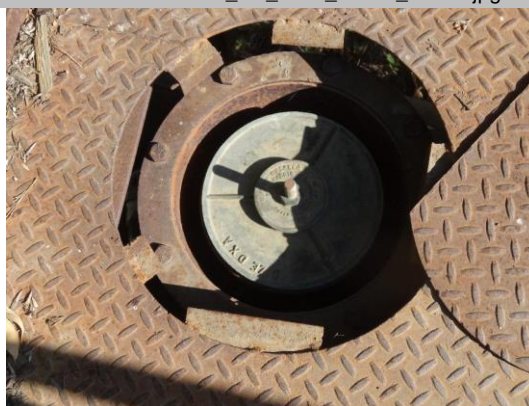
Photo 3 of 3 : UCIP_SP_2018_49386_63900.jpg

WS view: siphon breaker on pipe in steel deck on stream bank.

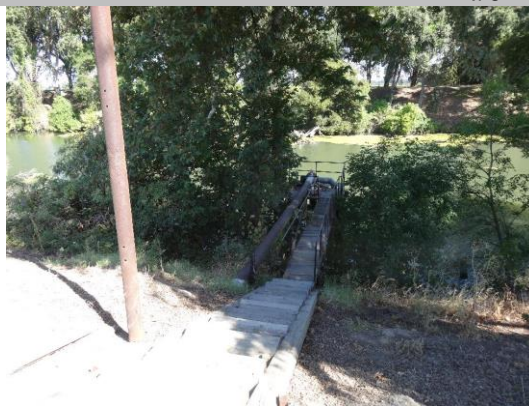
Photo 1 of 3 : UCIP_SP_2018_28265_51974.jpg

WS view: walkway, pipe, pump and support deck on river bank.

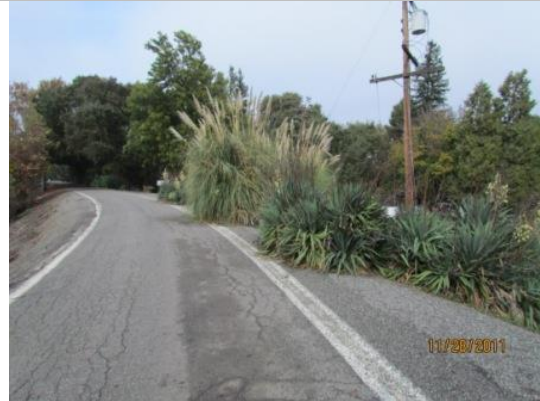
Photo 1 of 1 : SP_2018_RD0150_17_21_20180301_00008.jpg

Landscaping was found on the landside of the levee looking upstream.

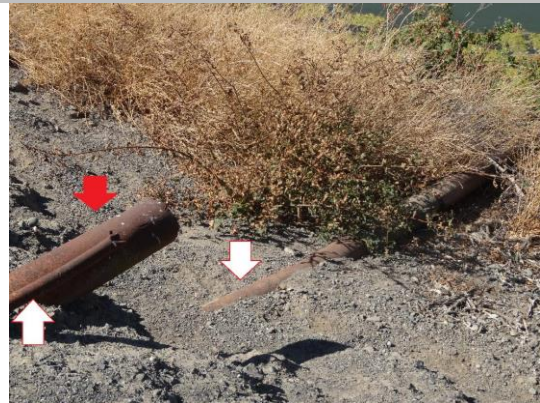
Photo 1 of 3 : UCIP_SP_2018_19403_32942.jpg

WS view: open ended 6" steel pipe (top-left), 1" steel pipe (bottom), and another 6" steel pipe (right) on levee slope.

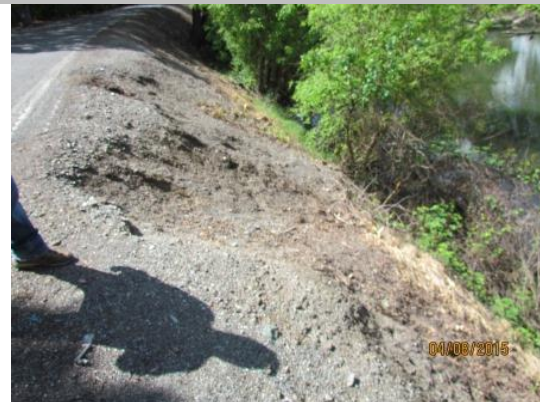
Photo 1 of 2 : SP_2018_RD0150_17_61_20180301_00057.jpg

LM Start	6.90	Rating **	M	Issue No.	61
LM End	6.90	Issue Type +	Ob	Location *	WS
Category	Earthen Levee			GPS Latitude/Longitude	
				Start	End
Item	Erosion / Bank Caving			38.396655 °	38.396655 °
				-121.535485 °	-121.535485 °
DWR ID	DWR_RD0150_03_s_2012_61				
Comment Code					
E1 : Note and monitor erosion site.					
Inspector Comment

Updated picture of the erosion on the waterside of the levee during spring 2015 inspection.

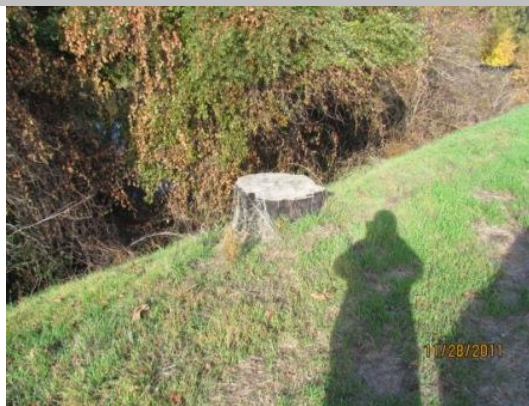
A tree stump was found on the waterside of the levee looking upstream.

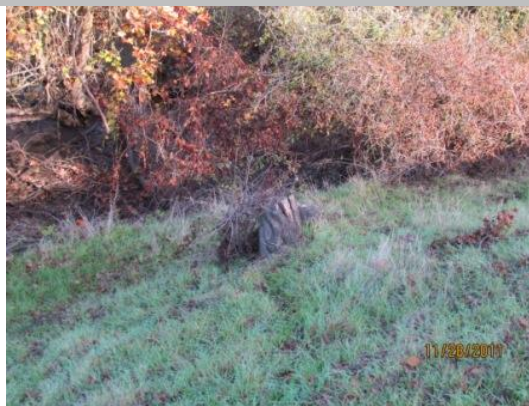
A tree stump was found on the waterside of the levee looking upstream.
